# Manhole Inspection Summary

Manhole # S05SS1012MH

**Location** Address: **3501 INGLESIDE AVE**

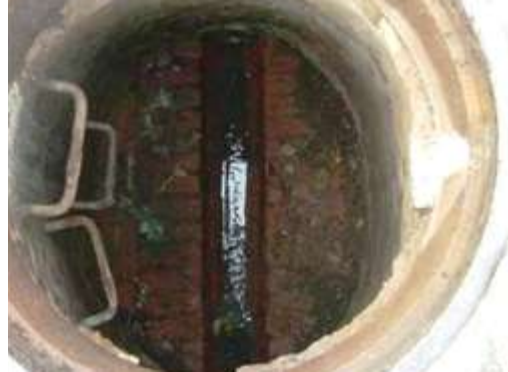
Top View

Evidence of surcharge - Bench debris.  
Channel debris.

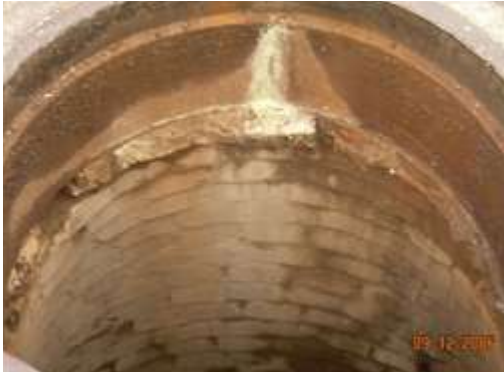
Defect

Frame leaks. Adjustment deterioration  
and infiltration. Corbel and Barrel  
infiltration.

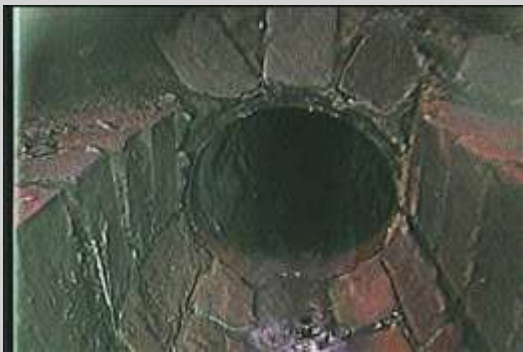
Pipe Out @ 12 O'Clock

Barrel deterioration and infiltration. Channel deterioration.

Infiltration: **Evidence** Pipe Seal Cond: **Unknown**
